Section	Applicable Model/s	Subject	Bulletin No.
02	1999 Millenia	KNOCKING NOISE FROM FRONT SUSPENSION	001/00
			Issued
			06/14/00
			Revised

All 1999 Millenia.

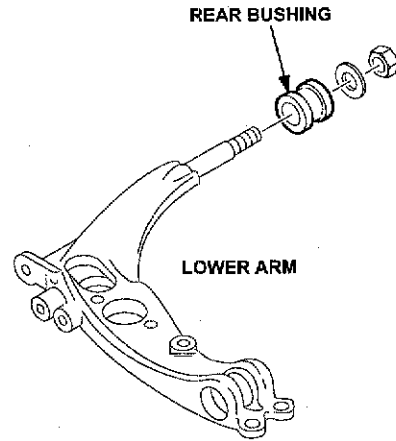
LEFT SIDE SHOWN (RIGHT SIDE SAME)

Some vehicles may exhibit a knock/thump/clunk noise from the front suspension area when turning over bumps, driving over rough roads at slow speeds and/or when applying the brakes. The noise appears to be more noticeable during colder temperatures. Cold temperatures can cause poor sealing of the front suspension, lower arm, rear bushing, resulting in deterioration of the bushing.

1. Verify customer concern.
2. Replace lower arm bushing (rear) on both sides of the vehicle. See Workshop Manual (section 02-13-5 FRONT LOWER ARM REMOVAL/INSTALLATION).

- To prevent any further noise, be sure to position the bushing so that the protrusion is facing up as shown below.
