Service Bulletin

Category T	Applicable Model/s 1995-96 Millenia	Subject HEADLIGHT AIMING SERVICE POINT	Bulletin No. 001/96 Issued 01/23/96 Revised
---------------	---	---	---

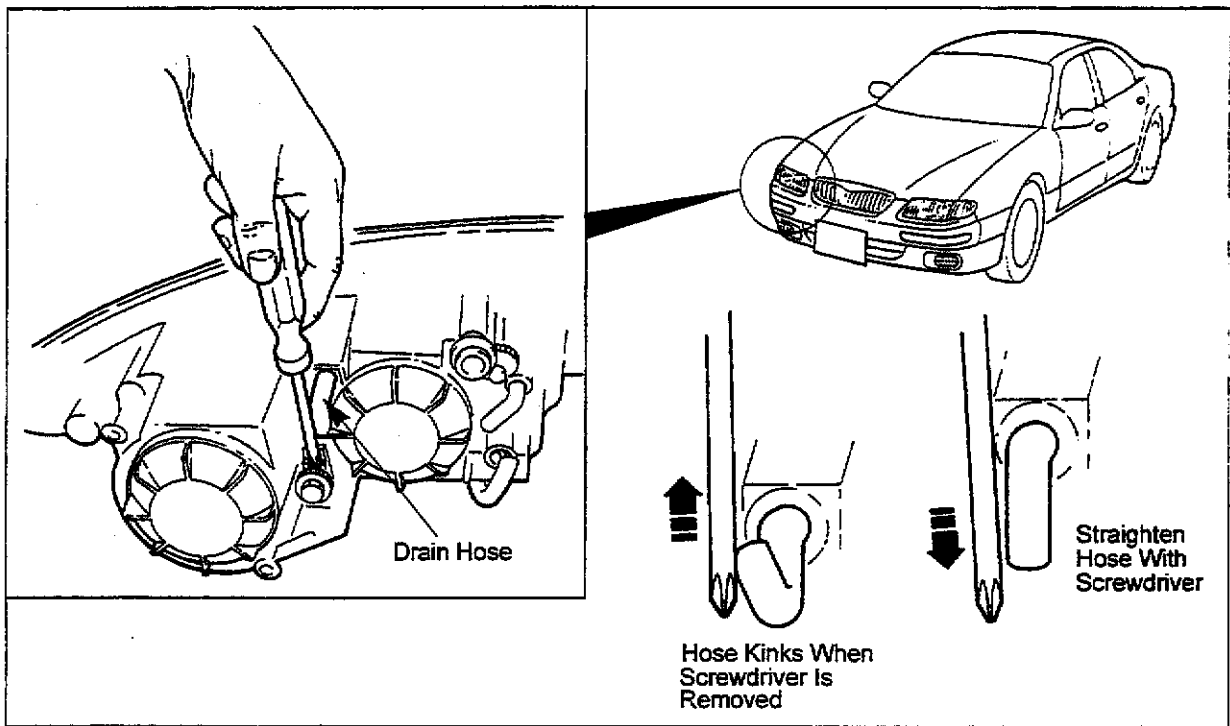
After adjusting the headlight aim, confirm that the drain tube is not kinked. These tubes are located around the headlight adjustment screws and may become kinked when the screwdriver is removed.
