Service Bulletin

Category N	Applicable Model/s 1995 Millenia	Subject HARD EFFORT TO UNLOCK STEERING LOCK SYSTEM	Bulletin No. 004/95
			Issued 3/15/95
			Revised 3/28/95

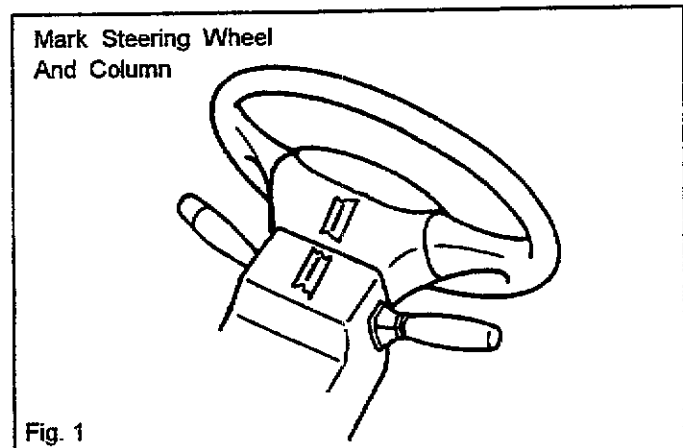
Turning the ignition key to start the engine may be difficult. This is caused by an unusually short steering wheel lock range. The unusually short range is caused by the steering shaft being slightly out of position.

1. Verify the complaint.
2. Check the steering wheel for proper centering.
3. Set the front wheels straight.
4. Apply masking tape to the top of the steering column and the steering wheel as shown in Fig. 1.
5. Draw a line on the tape (steering wheel to steering column) to show alignment.
6. Disable the tilt function by turning the auto switch OFF.
