Service Bulletin

Category S	Applicable Model/s 1995-97 Millenia	Subject SUN ROOF LOWER PANEL COVER LOOSE	Bulletin No. 009/97 Issued 05/19/97 Revised
---------------	---	--	---

NOTE: Revision to Service Bulletin Cat. S 049/96

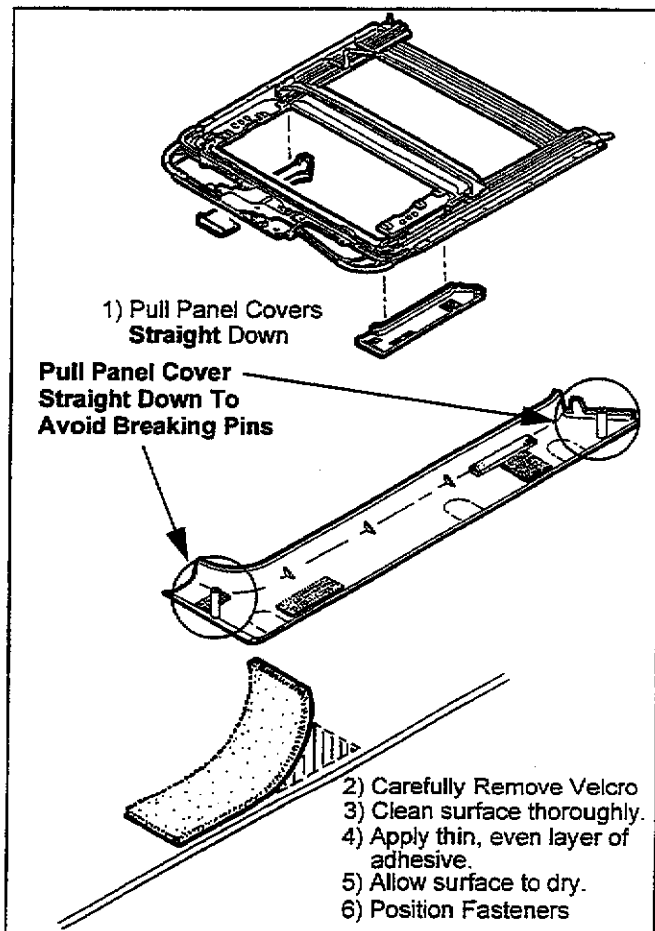
When the sun shade is opened, the lower panel cover may hang down. This is caused by insufficient adhesive holding the velcro fastener. To prevent peeling off, the velcro fastener is now installed on the lower panel cover by heating.

1. Remove the left and right lower panel covers.

2. Remove all velcro fasteners from panels.

3. Clean surfaces thoroughly with superpolite alcohol.

4. Apply thin even layer of adhesive to both velcro and panel cover with brush.

5. Allow surface to dry only until surfaces are dry to the touch, but tacky.

6. Position the velcro fastener on the lower panel cover and apply pressure to affix the fastener to the panel cover.
