Service Bulletin

Category U	Applicable Model/s '95-'97 Millenia	Subject A/C ODOR & BLOWER NOISE DUE TO FOREIGN SUBSTANCE	Bulletin No. 011/97 Issued 06/19/97 Revised
---------------	---	--	---

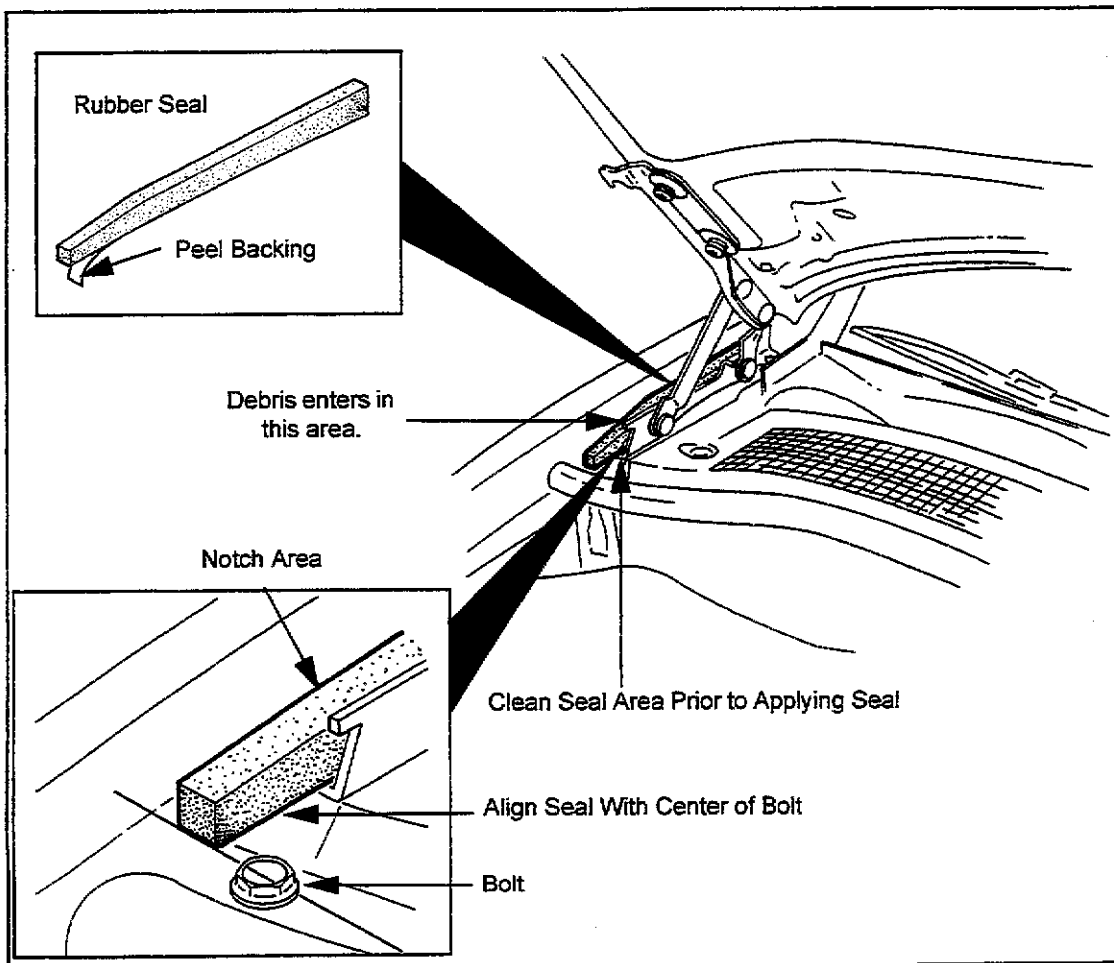
Dead leaves or other debris enter the notch on the front fender (passenger side), and are sucked into the blower unit, causing unusual noise when the blower motor rotates. Debris also collects in the cooling unit and may become rotten due to moisture. As a field countermeasure, a rubber seal is applied to the notch on the front fender (passenger side). When you encounter a customer complaint on this concern, apply rubber seal according to the instructions in this bulletin.

1. Use isopropyl alcohol to wipe moisture, grease and dust off the rubber seal application position.
2. Apply adhesive backed rubber seal as shown in the illustration below.
3. Remove the blower motor to remove the foreign substances from the blower fan and the blower motor casing.
4. If an unusual odor occurs, remove the cooling unit to remove debris from the unit.
 - Clean each part and reinstall.

NOTE: The front end of the rubber seal should be aligned with the center of the bolt.
