Service Bulletin

Category S	Applicable Model/s 1995 Millenia	Subject ASSIST HANDLE DETACHMENT	Bulletin No. 027/94
			Issued 8/10/94
			Revised

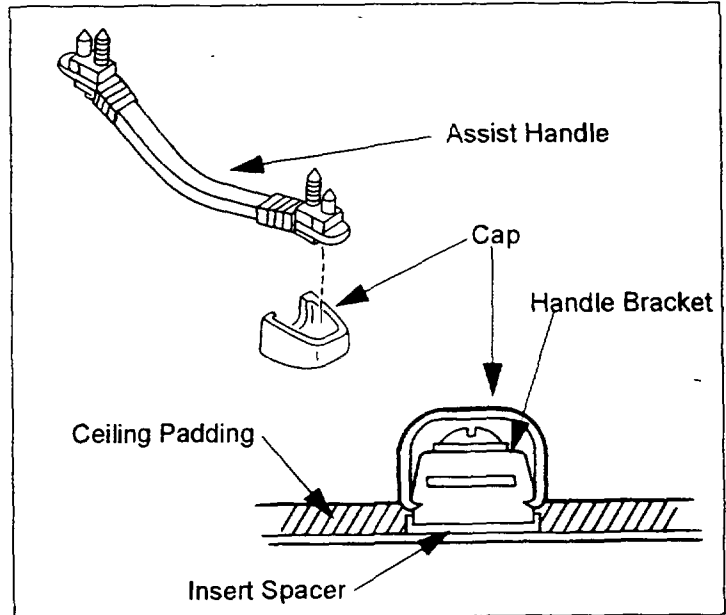
During normal use, the assist handle cap located above the door may become detached. This is caused by a variation in the thickness of the ceiling padding. If the ceiling padding is too thick, the assist handle cap is pushed outward.

1. Remove the assist handle.
2. Insert a spacer between the handle bracket and the body.
3. Install the assist handle with a new cap.
