Subject: LACK OF HEAT IN PASSENGER COMPARTMENT	Bulletin No: 07-002/02
	Last Issued: 04/22/2002

2001 Millenia models with VINs lower than JM1 TA22** 11 714921, or built before May 9, 2001.

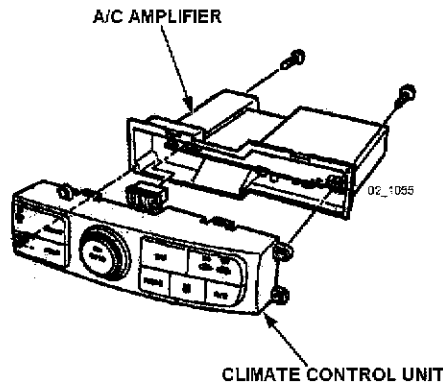
During normal heater usage, the customer may complain of a lack of heat in the passenger compartment. This may occur even if the auto mode temperature control is set high (77 degrees F or higher). The cause may be due to incorrect logic in the A/C amplifier.

1. Verify customer concern.
2. Follow the Workshop Manual (section 07-40 CLIMATE CONTROL COMPONENT DISASSEMBLY/ASSEMBLY), and replace the A/C Amplifier with a revised part.
